Report

REFERENCE: Evaluation of Femoral Ball Head and Acetabular Liner -
Pamela A. Ahmed v. Johnson & Johnson Healthcare Systems, Inc., et al
Location of Incident: Mobile, Alabama
Date of Incident: November 4, 2020
File Number: 900-2021-12
Case Number: 1:22-cv-00190
EDT Case Number: BHM10620-70811

Evaluation of Femoral Ball Head and Acetabular Liner -
EDT Case Number: BHM10620-70811

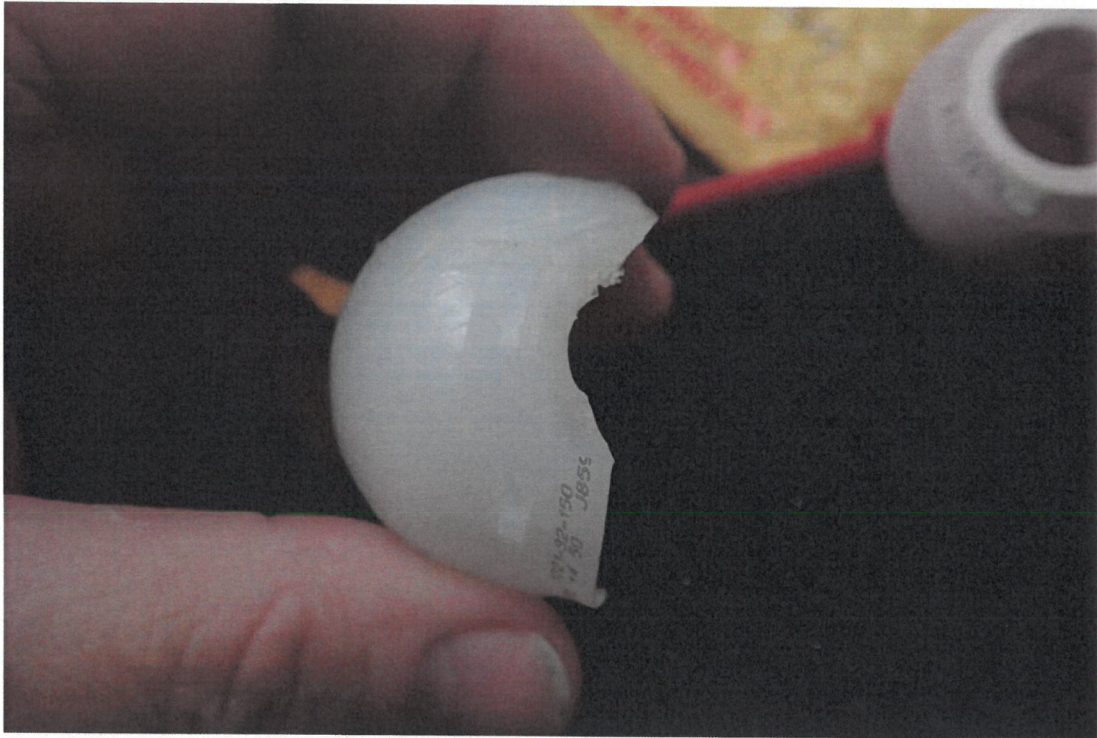
Damage to the liner consists of significant permanent deformation of the lip and the liner's anti-rotation tabs. Five of six anti-rotation tabs are sheared off. Striations that are oriented from the pole toward the equator indicate the direction of movement and shear on the liner's outer surface. Rotation in two orthogonal planes is noted. The first plane is aligned with the

hemispherical axis. The second is at a right angle to the axis that effectively rolled the liner out of the metal acetabular shell. The majority of the striations and shear lines are oriented at right angles to the liner's equator. Photography of white plastic is difficult due to lack of contrast, but the striations may be seen in Figures 6 – 10.

Figure 7 Equatorial view of the damaged liner

3. The anti-rotation tab design is defective. Sheared anti-rotation tabs indicate a design defect. The anti-rotation tabs on the liner can be made larger and/or increased in number to as many as twelve.

4. The shape of the anti-rotation tabs can be changed to remove the mechanical advantage of the sloped sides. Sloping the ring openings and the tabs' sides makes it easier to shear the anti-rotation tabs off of the liner.

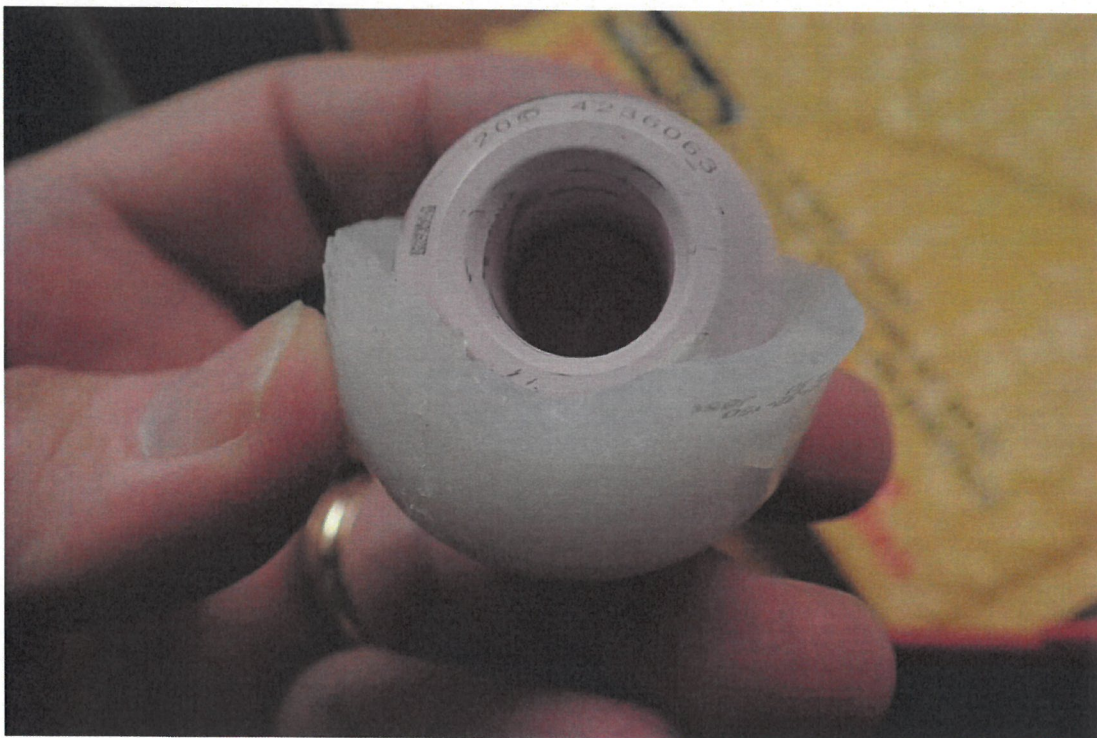
manufacturing defect. Regarding design, it appears that the +5 mm extension of the ball/stem mounting may increase the chances of impingement by limiting the range of motion further. Figures 8 and 9 show that impingement was taking place and deforming the liner lip. Figure 8 also shows that the head extension did not contact the lip but rotated inside of the liner lip.

Figure 8 Head in the liner showing the conformance of the stem to the divot in the liner lip

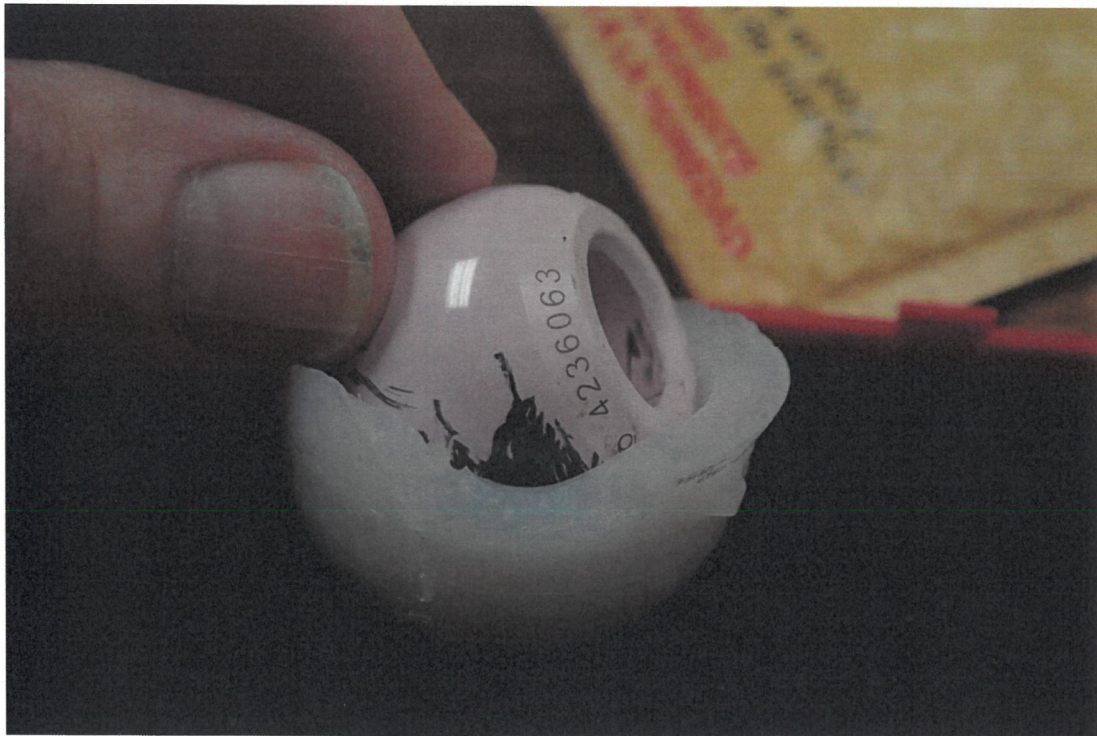
Figure 9 Stem angle matching the deformation of the remaining lip portion
